WHC-IP-0716

Corrosion in Waste Drums from the 183-H Solar Evaporation Basin Cleanout Project

**Westinghouse
Hanford Company** Richland, Washington

This report describes ultrasonic inspection results from efforts to characterize drum degradation and analyzes the causes of the degradation.

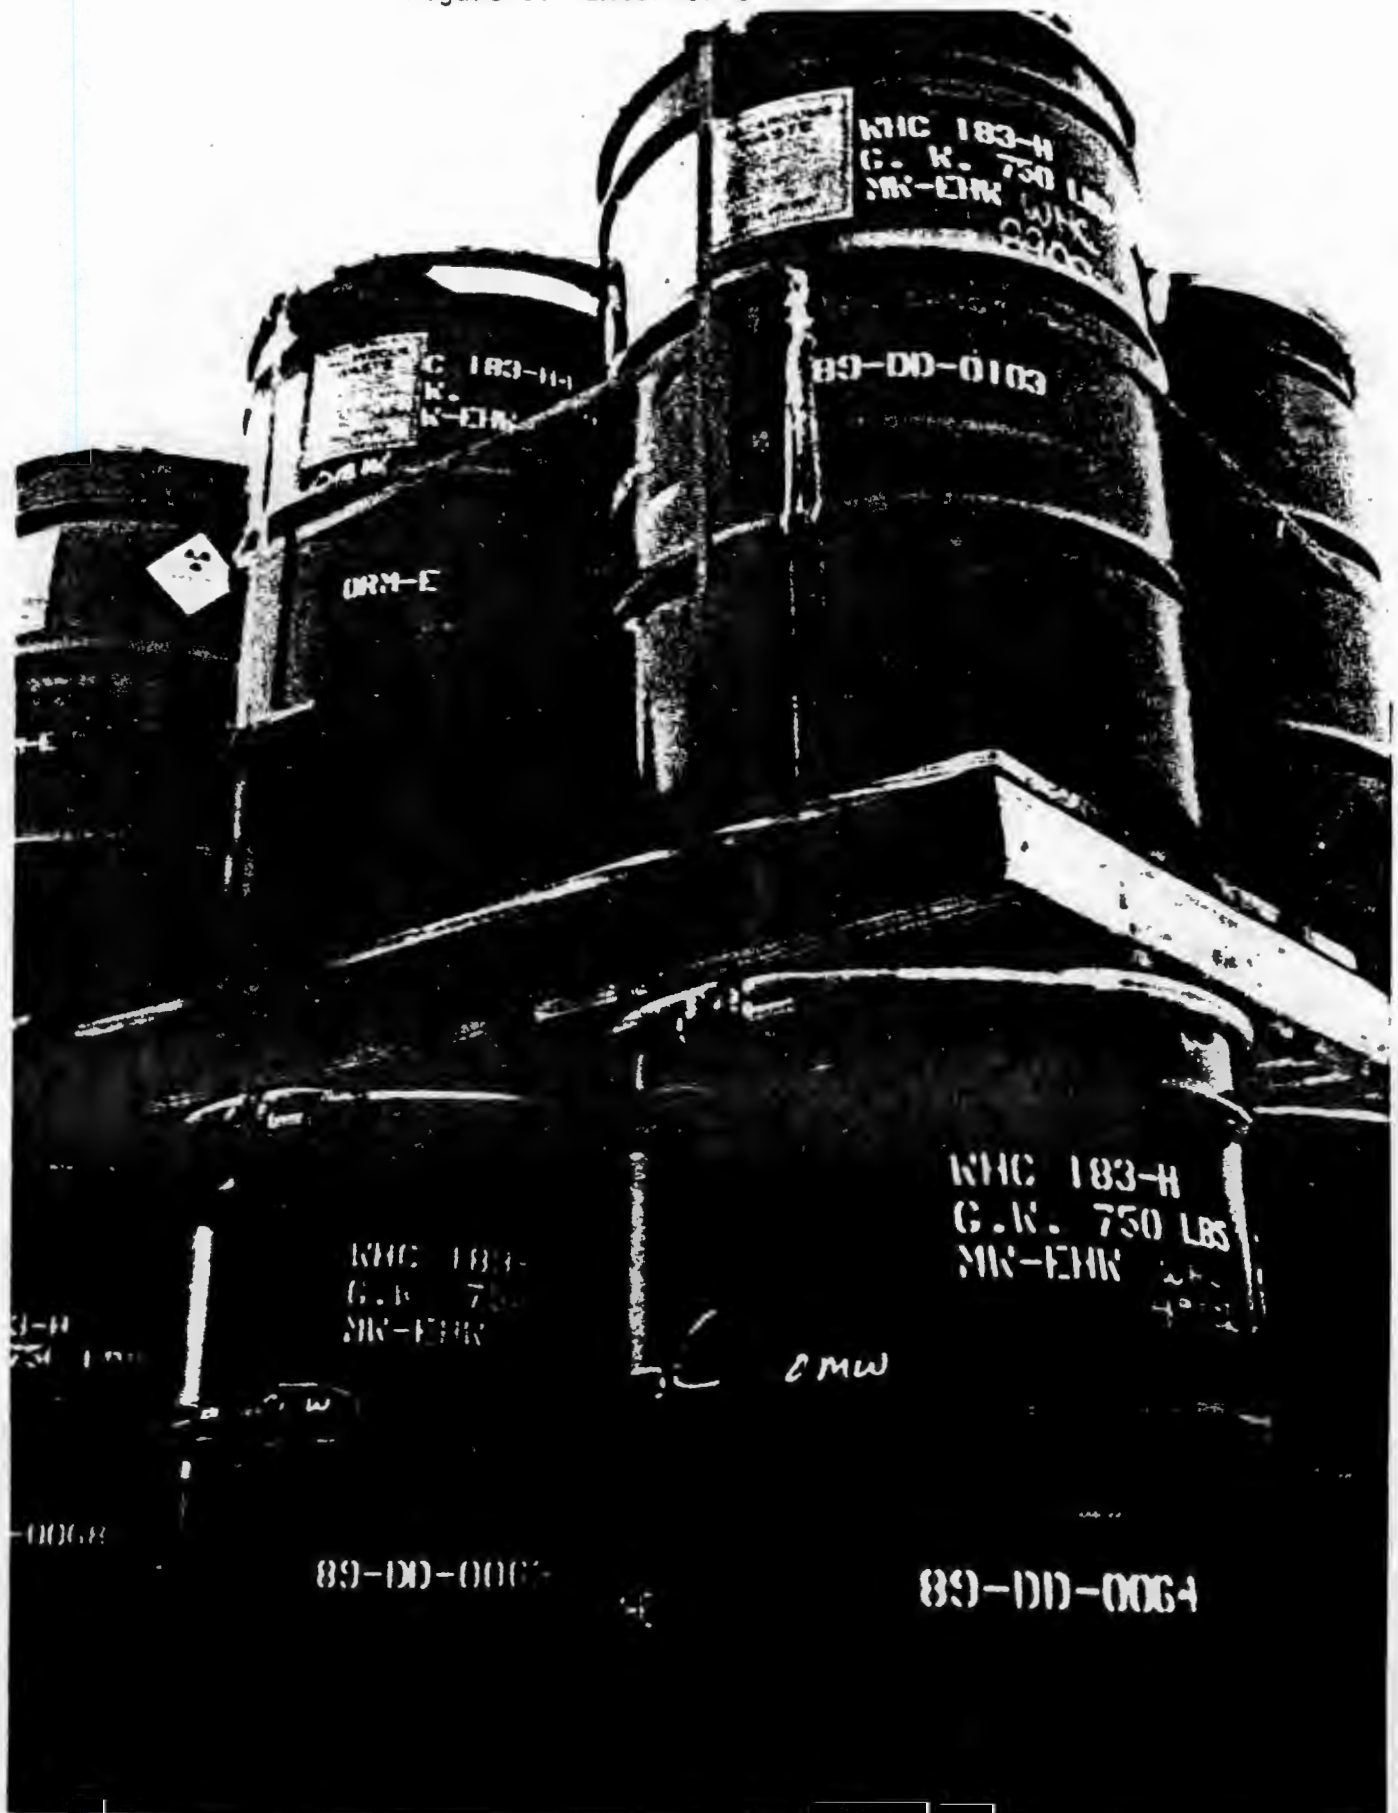
Figure 3. Exterior of Failed Drums.

The exterior of several failed drums in the storage stack is shown in Figure 3. Failure locations are marked by white circles on the bottom drums. Note the drum contents leaking from the top drum (89-DD-0103).

The appearance of the failures from the exterior of the drums suggests pitting, as the failure areas generally are small diameter holes. Some drums have large blisters rather than holes, but this is disbonded paint resulting from corrodant penetrating the steel wall and forcing the paint from the drum wall. The last step in the failure process is penetration of the paint layer. The interior surfaces of the drums show corrosion products from general corrosion but not enough attack to attribute failure to general corrosion.

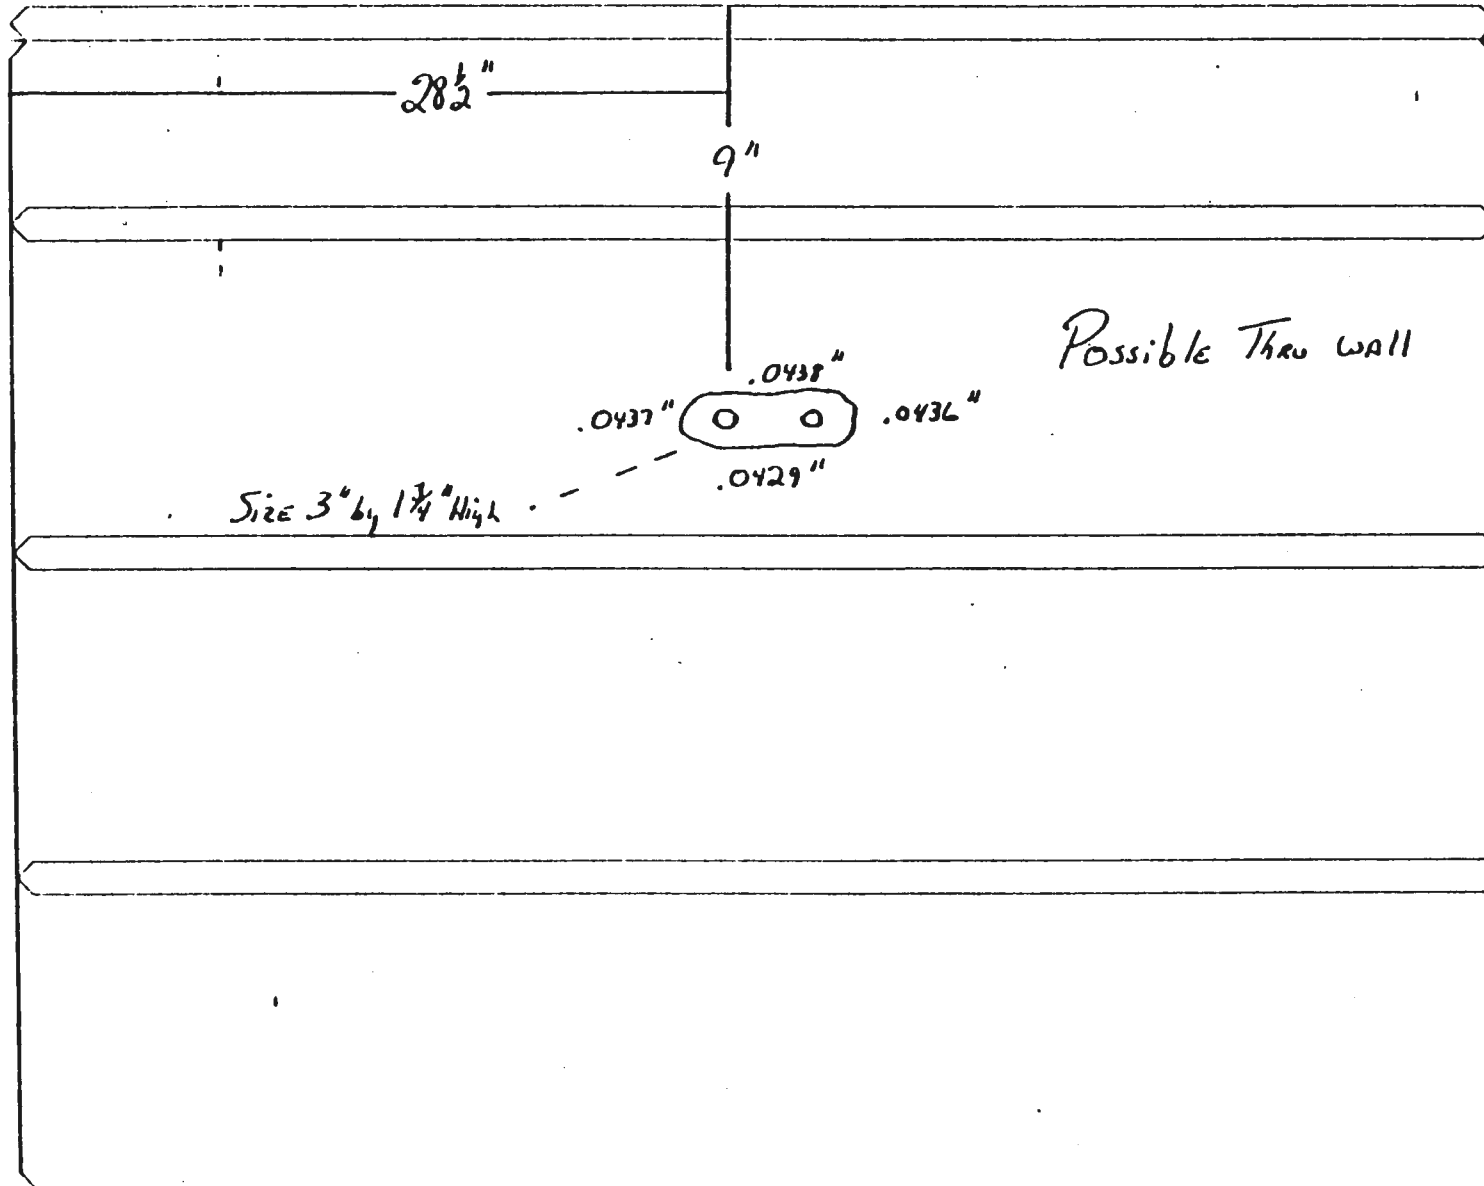
Drum 320

WHC PROCEDURE NO. NOT-UT-9000, Revision No. 1 Appendix A , Revision No. 1 Special Technique No. <input type="checkbox"/> NA				RESULTS <p>These Drums have blisters from inside corrosion. Size and location as noted. See Pages 2 thru 7. Inside corrosion was mapped by taking Thickness Readings. No Reading equals Corrosion. Thickness Readings noted are as close to blister as Reading could be taken. This was marked and then used for the size of the inside corrosion.</p> <p>⊙ - Indicates either a blister or thru wall indication.</p>		
COVERAGE <input checked="" type="checkbox"/> Spot <input type="checkbox"/> 100% of area requested				INSTRUMENTATION Dig.-Sonic Mfg. SONIC Model 502 Standards Lab No. 584-31-50-016 Expiration Date 7-19-91		
CALIBRATION STANDARD(S) Standards Lab No. 584-99-30-091 Expiration Date 11-13-90 Standards Lab No. 584-99-30-117 Expiration Date 2-21-92				TRANSducer Diameter 1/4" Frequency 15 MHZ Mfg. SONIC Serial No. 177265 Stand Off 1/2"

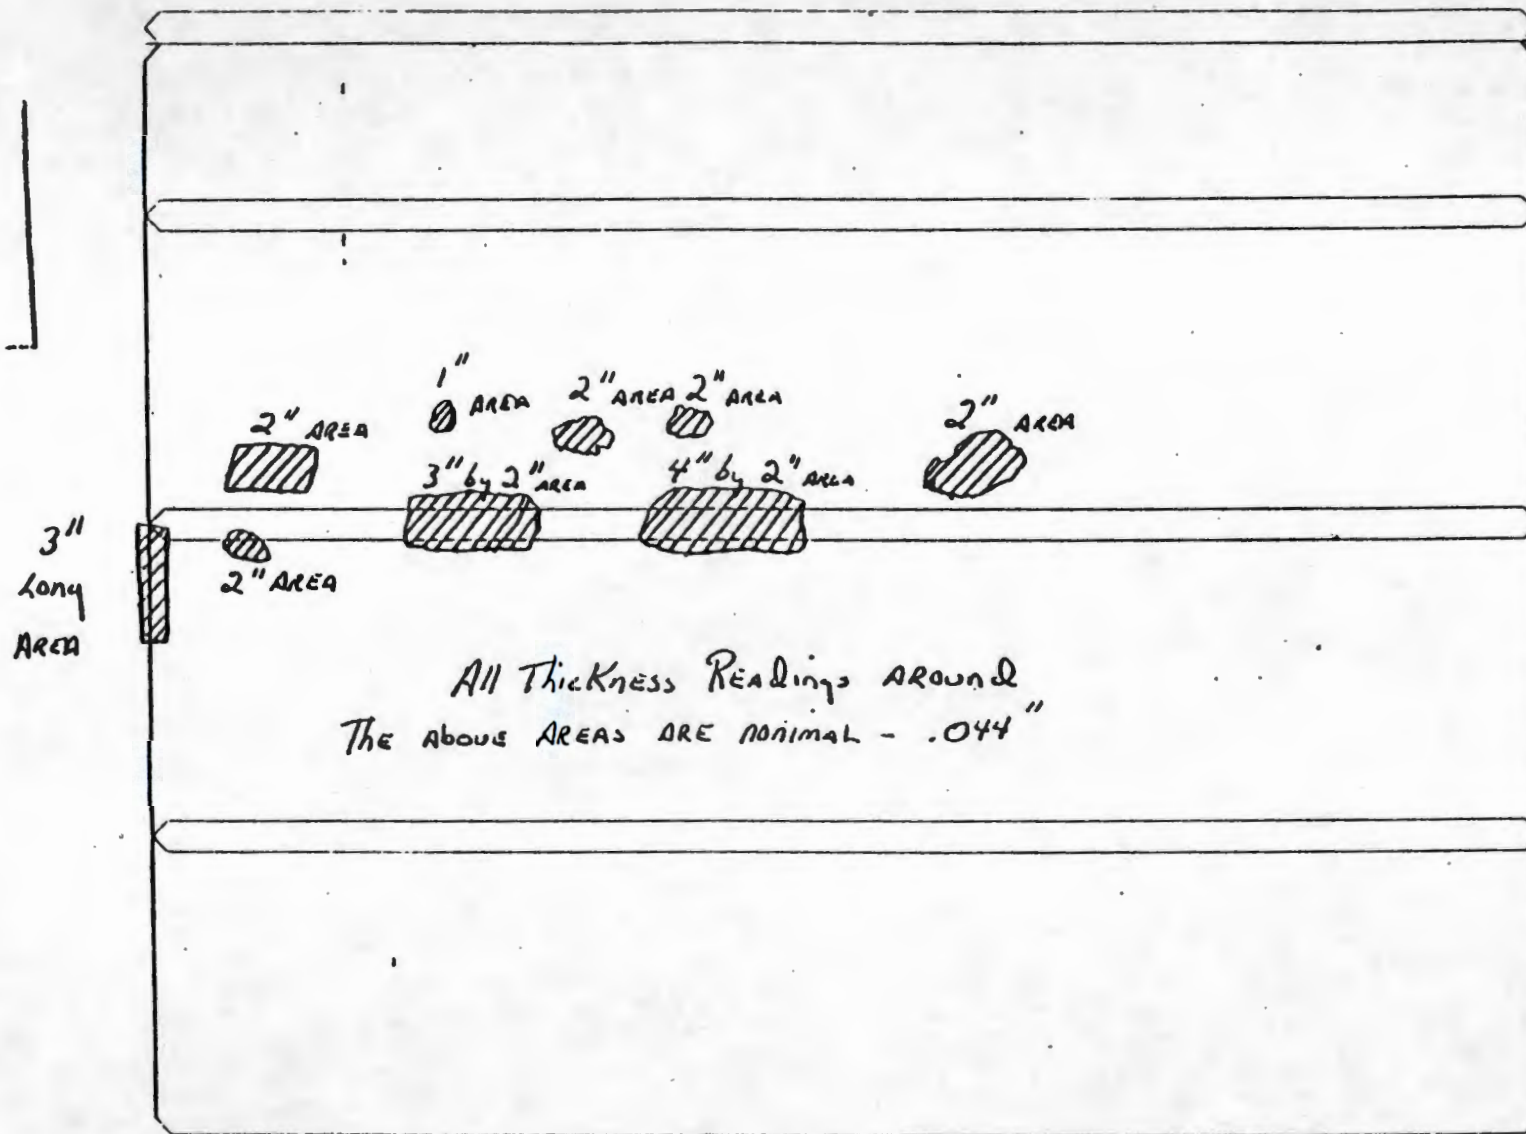
Drum 1407

All Thickness Readings around
The above AREAS ARE normal - .044"

Corrosion AREAS on Outside of Drum
(blinded)
